Home Inspection Report

March 5, 2010

123 Main Street

Anytown, NC 28000

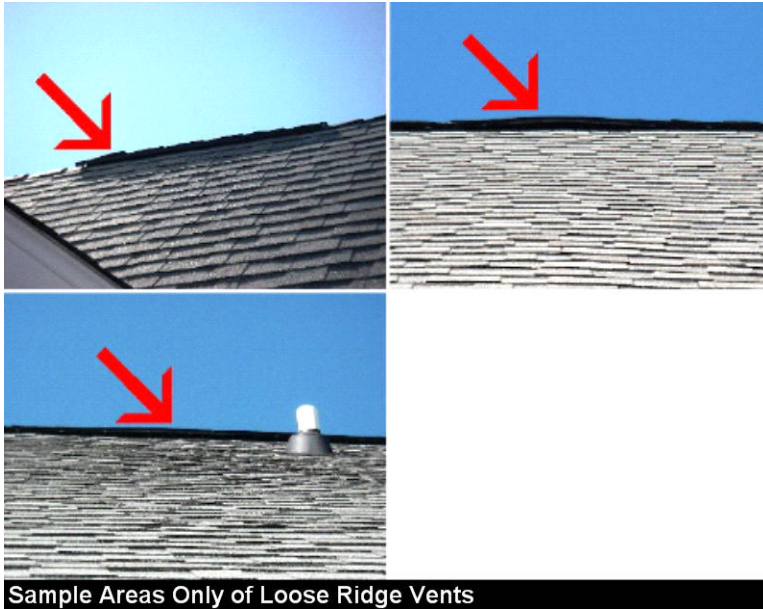
Ridge vents on right front reversed gable ridge and on main ridge are loose.

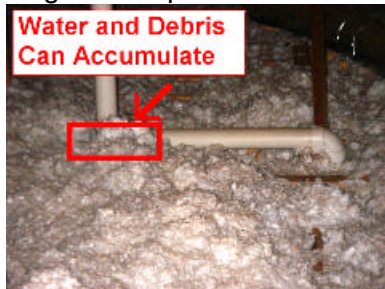
Negative slope is noted in attic on 3" vent. Water can accumulate and blockage can occur.

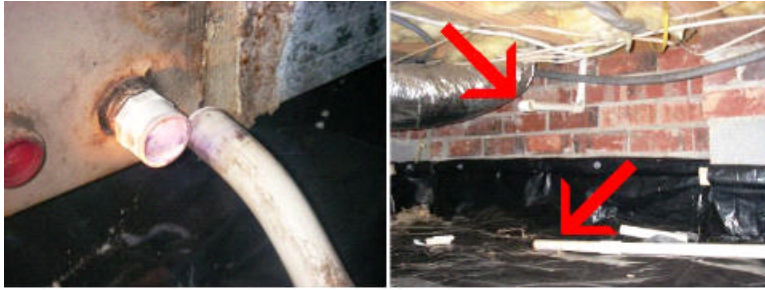
Condensate line installed, Line not fully visible, however, both unit's lines are disconnected in the crawlspace.

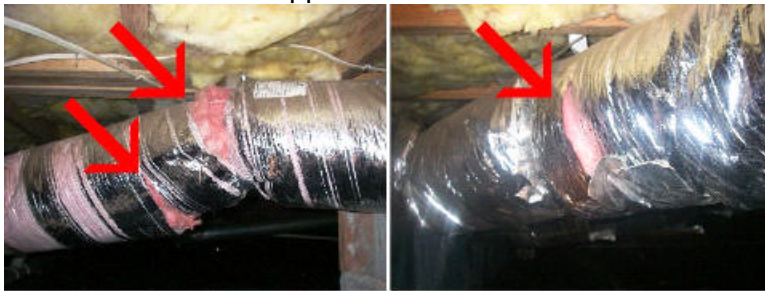
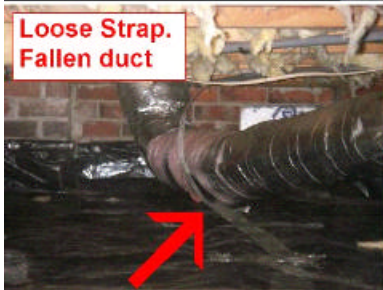
Minor retaping is needed in the crawlspace due to exposed insulation. Duct strap broken on large duct. All ducts should be supported.

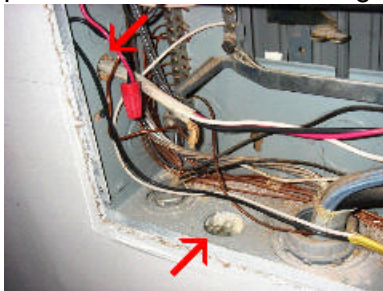
30 amp breaker would not reset at A/C panel. A dead short is suspect. Missing covers on openings in panel at bottom and missing strain relief at wire on left side of garage panel. These are a fire hazard.

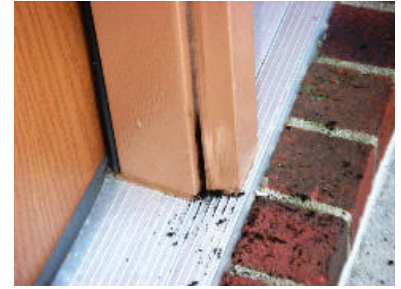
Functional. Front door mullion trim on lower latch side has fungi growing from behind the metal trim.

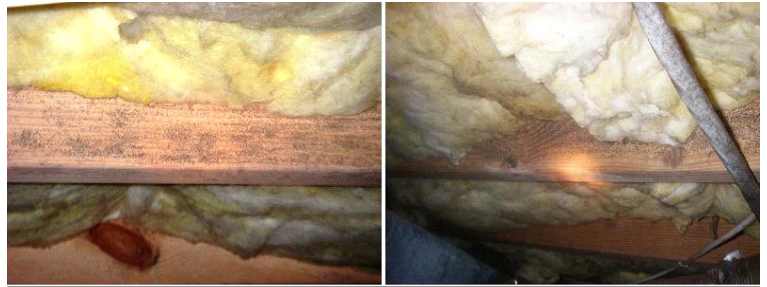
Functional. Fungi growth noted on most joists.

Sample Areas Of Fungi Growth

WATER INFILTRATION This property has evidence prior water infiltration, which is a condition deemed to increase the likelihood of fungi growth. CJS Home Inspections makes no warranty as to the current or future existence of fungi in this property and is not liable for the potentially harmful effects thereof. The Environmental Protection Agency (EPA) recommends that any indoor fungi growth be addressed and that all water or moisture sources be eliminated."

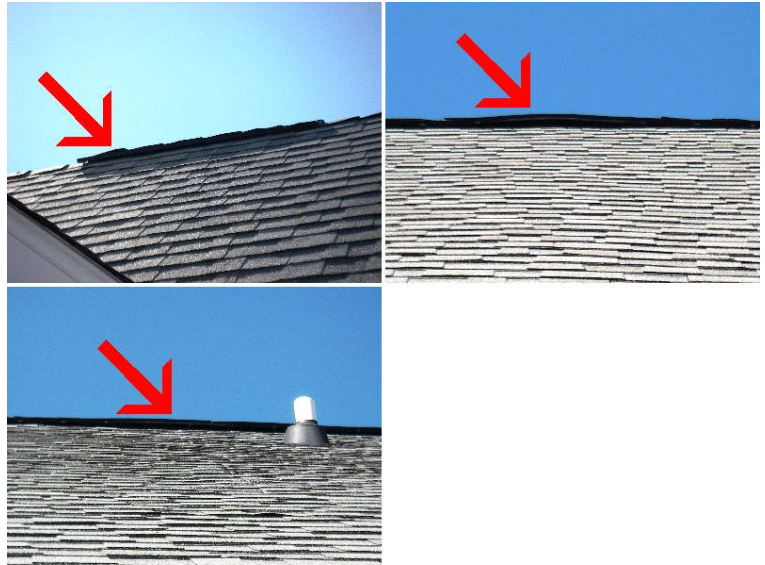
Good condition/within useful life. Ridge vents on right front reversed gable ridge and on main ridge are loose. A licensed roofing contractor should be called to make further evaluation of all ridge vents and repair as needed.

Sample Areas Only of Loose Ridge Vents

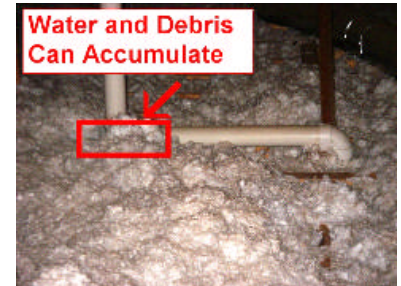
4.8 CONDITION: Negative slope is noted in attic on 3" vent. Water can accumulate and blockage can occur. A licensed plumbing contractor should be called to further evaluate and repair as needed.

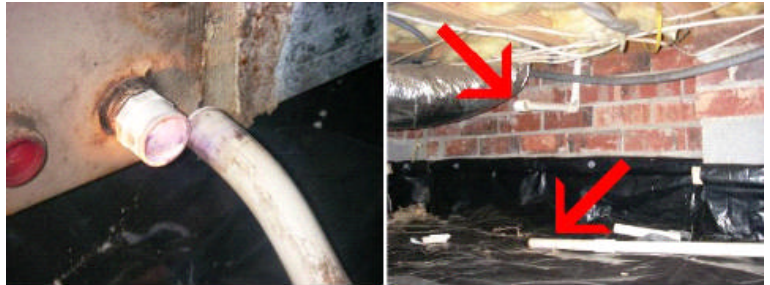
- 5.13 TYPE: Central, Electric. Operational.
5.14 POWER SOURCE: 220 Volt, Electrical disconnect present.
5.15 SYSTEM CONDITION: Unit failed to operate. Exterior small unit was making a humming noise. This is irregular. A licensed HVAC contractor should be called to further evaluate and repair as needed.
5.16 CONDENSATE LINE: Condensate line installed, Line not fully visible, however, both units lines are disconnected in the crawlspace. A licensed HVAC contractor should be called to further evaluate and repair as needed.
5.17 SECONDARY AIR CONDITIONING SYSTEM CONDITION: Operational.

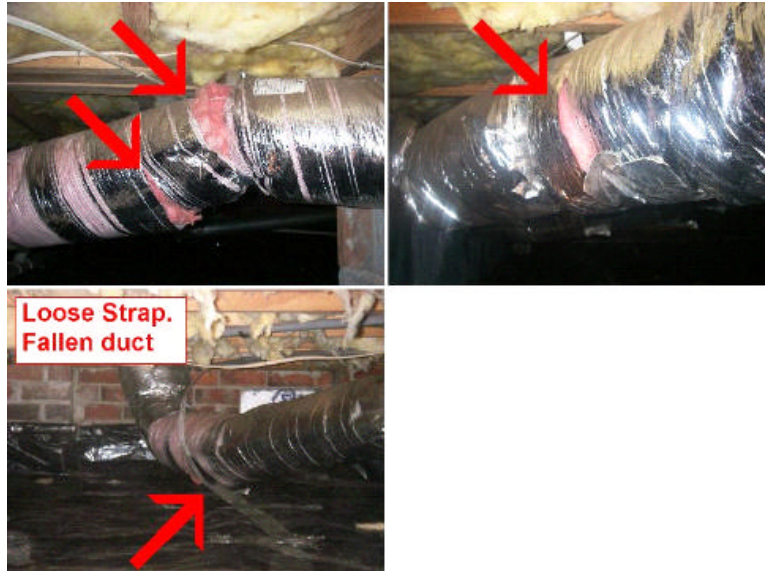
5.19 DUCTS/AIR SUPPLY: Operational. Minor retaping is needed in the crawlspace due to exposed insulation. Duct strap broken on large duct. All ducts should be supported. A licensed mechanical contractor should be called to further evaluate and repair as needed.

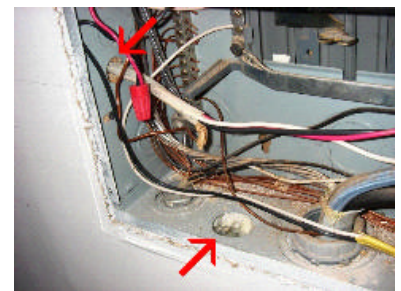
6.6 SUB PANEL NOTES: Circuit and wire sizing correct so far as visible, Grounding system is present. 30 amp breaker would not reset at A/C panel. A dead short is suspect. Missing covers on openings in panel at bottom and missing strain relief at wire on left side of garage panel. These are a fire hazard. A licensed electrical contractor should be called to further evaluate and repair as needed.
